Security Assessment Report
Torrey Pines Facility

Assessment Date: September 16, 2022

Secure Core LLC

Assessor: Jeff Osgood, Security Director

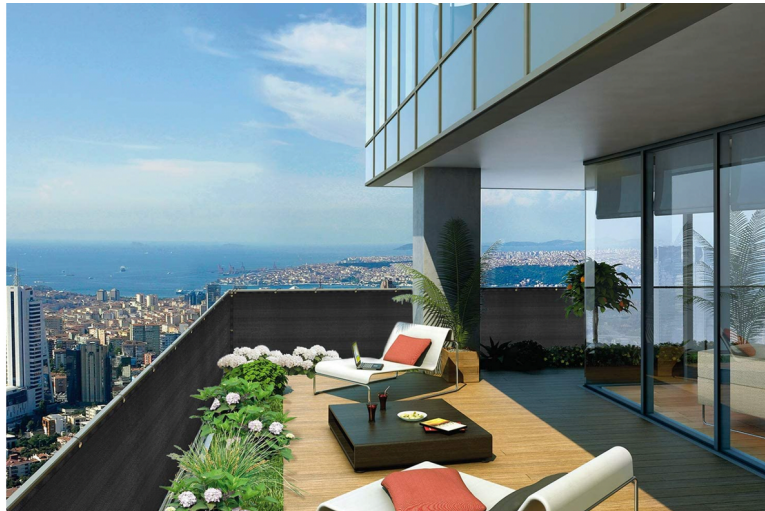
Vulnerability: Security Camera Coverage

Activity around the perimeter balcony is not monitored by a security camera system. The ability to detect and respond to an incident may be delayed, thus exposing facility assets to risk. Limited security cameras reduce deterrence effects, may encourage unlawful activity in unsupervised areas, and hinder the ability to conduct a proper post-incident investigation. There are no cameras on any of the balconies where employees eat lunch and have meetings.

- **Camera Repair/Replacement**

Repair/replace existing security camera/s around the balcony to facilitate continuous monitoring. Sufficient security camera coverage may substitute the need for frequent patrols in the area. For increased deterrence, install cameras in overt locations, strategically placed to avoid vandalism, sabotage, or environmental damage. Ensure faces of personnel within the frame can be identified. Motion activated security camera sensors may also be used to prioritize monitoring efforts.

- **Security Camera Installation**

Install security camera/s around the perimeter balcony to monitor surrounding activity. Sufficient security camera coverage may substitute the need for frequent patrols in the area. Cameras installed should function in all lighting and weather

conditions, day and night. For increased deterrence, install cameras in overt locations, strategically placed to avoid vandalism, sabotage, or environmental damage. Motion activated security camera sensors may also be used, recording only when activity is detected.

- **Security Signage**

Post security signage on and around the balcony to deter unauthorized personnel and unlawful activity in the area. Include wording such as, "No Trespassing," "Private Property," or "Under CCTV Surveillance." As a deterrent, proper signage can advise personnel of security systems and administrative regulations exercised on the property. Signage should be concise, legible from a distance, well lit, and printed in all relevant languages.

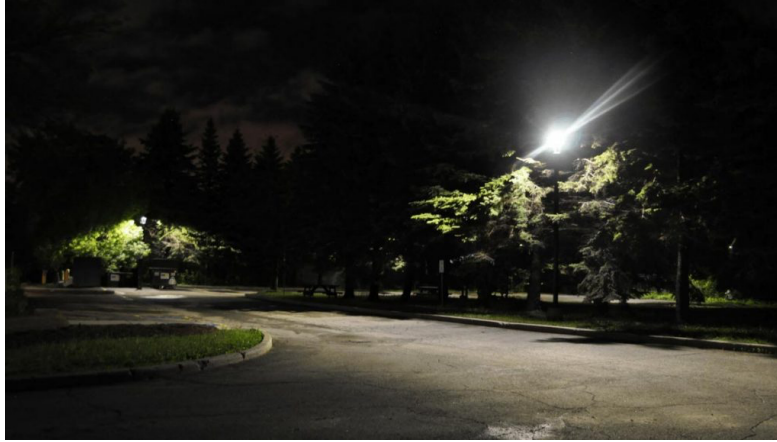
Vulnerability: Lighting

Insufficient lighting along the building frontage may increase the risk of accidental injury and promote criminal or vagrant activity in the area. Inadequate lighting may render existing surveillance equipment ineffective creating gaps in the facility's monitoring ability. Additionally, limited lighting along the building frontage

mayPoor lighting that is a safety hazard to employees and individuals walking up to the main entrance especially at night you cant see the 10 feet in front of you. impact access control procedures.

- **Continuous Lighting**
Install continuous lighting along the building frontage. Proper continuous lighting requires a series of fixed overlapping cones of light providing constant illumination in low light conditions and during hours of darkness.
Reference: FEMA 426, 2-67, 2-68
- **Standby Lighting**
Install standby lighting along the building frontage. Standby lighting activates when motion is detected by the sensor, providing deterrence and exposure.
Reference: FEMA 426, 2-68

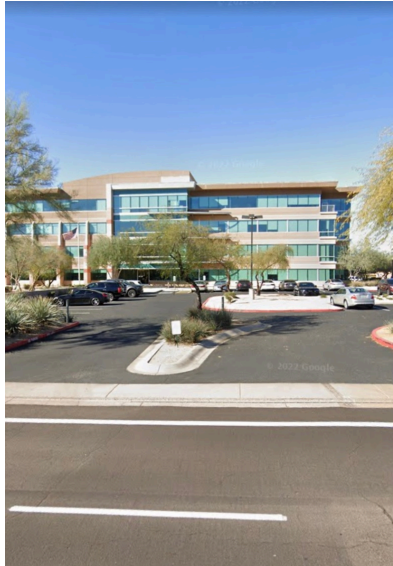
MA C Vulnerability: Insufficient Access Control

Vehicle and/or pedestrian access to the parking lot is not controlled. Unauthorized vehicles may park illegally, observe, or gain access to the facility. In some cases, unrestricted access to a parking lot may expose the facility and/or personnel to the risk of accidental or deliberate vehicular impact.

- **RFID Card Reader**
Install an RFID card reader at the parking lot entrance, ensuring only authorized personnel equipped with a valid card/FOB are permitted access into the parking area. This system automates the access control process and typically interacts with locking devices which authorize and log entry to the parking area.
