**Security Assessment Report**

**Company HQ**

**Department Solutions**  
9111 Falmouth Ave  
Playa Del Rey, CA, 90293

**Assessment Date:** January 21, 2026

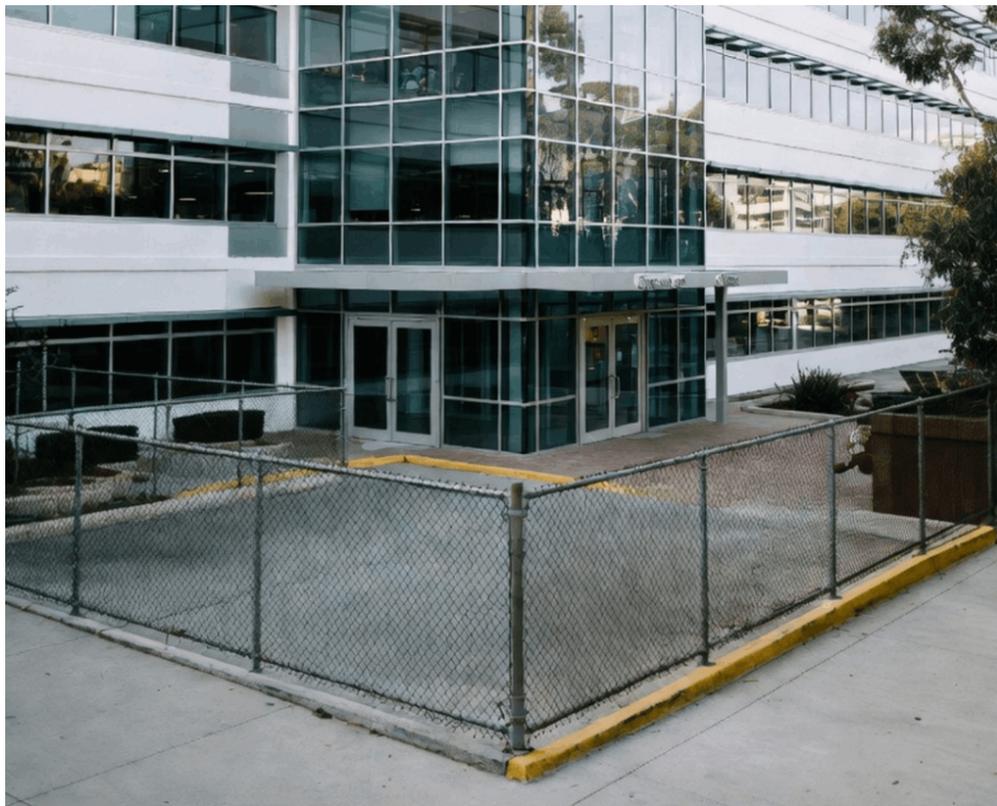
### **Vulnerability: Deficient Perimeter Fence/Wall**

The facility is not enclosed within a perimeter boundary such as a fence or wall. The existing perimeter is insufficient and will not prevent an intruder from accessing exclusive areas.

- **Anti-Climb Fencing**

Install an anti-climb fence or wall. Different styles of anti-climb fencing are available, most consisting of vertical bars with horizontal supports designed to make scaling difficult. Additional measures may include appropriate lighting, security cameras, alarm devices, and signage to augment the perimeter boundary.

- **Fencing/Wall Enclosure**

Install a perimeter fence or wall enclosing the facility within a physical boundary. Fencing types include but are not limited to chain-link, aluminum, anti-climb (CPTED), barbed wire, concertina, triple-stranded concertina, welded mesh, buried fencing, wrought iron, and wire, all of which are designed to deter and delay intrusion. Additional measures may include appropriate lighting, security cameras, alarm devices, and signage to augment the perimeter boundary.

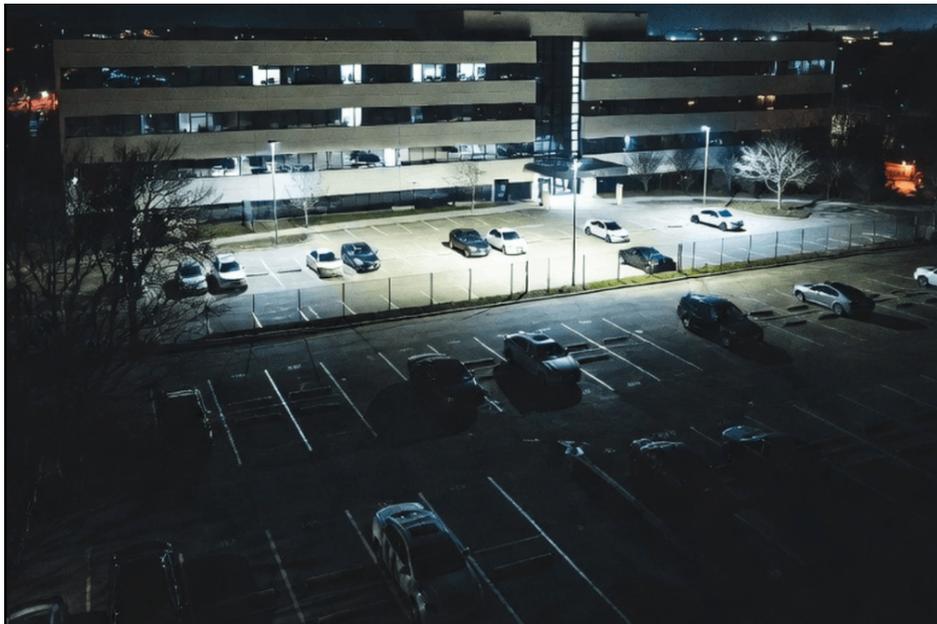
**Vulnerability: Insufficient Lighting**

There is insufficient lighting in the parking lot. Inadequate lighting creates general safety hazards and may promote unlawful activity in the area. Additionally, limited lighting may render existing surveillance equipment ineffective.

- **Illumination Quality Upgrade**

Upgrade the current parking lot light bulbs and/or luminaires for better illumination capabilities. Different light sources have different abilities and limitations. When choosing the optimum light source, various factors should be

considered, such as the threat level, cost of change and usage, life usage expectancy (in hours), accessibility, maintenance, environment, and design

- **Standby Lighting**

Where continuous lighting is not required, install standby lighting within the parking lot. Standby lighting activates when motion is detected by the sensor.

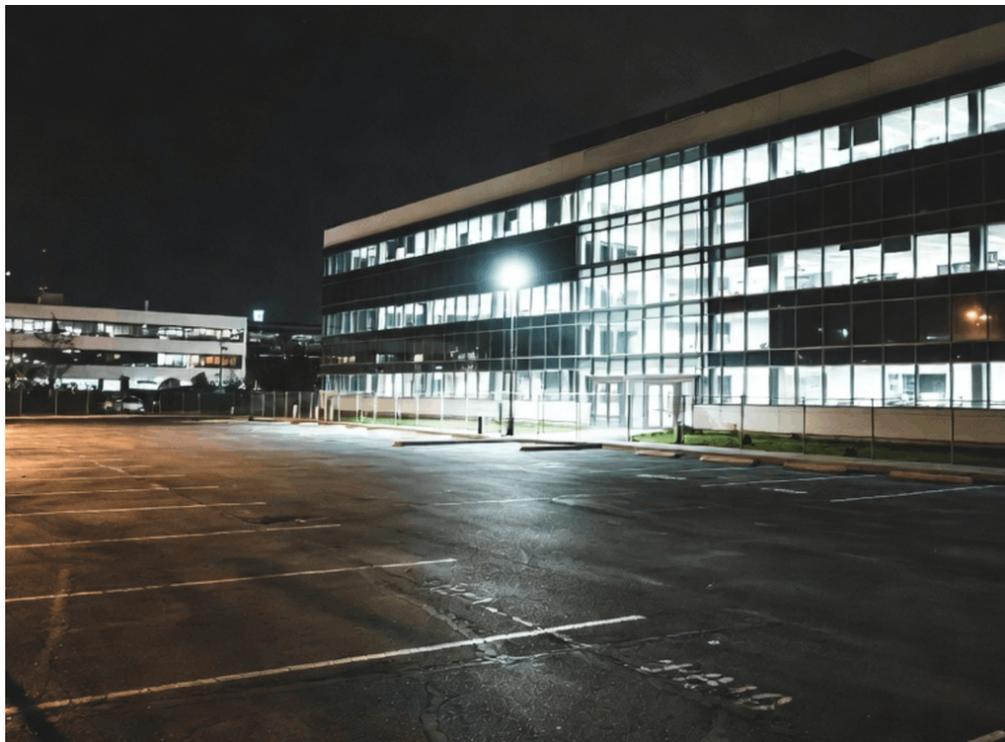
**Vulnerability: Vehicular Impact**

Both the facility's exterior and pedestrians in the parking lot are vulnerable to vehicular impact. Injuries and/or structural damage may occur due to an accidental or intentional vehicular incident.

- **Planter Placement**

Place planters in strategic locations in and around the parking lot. Planters should be anchored and filled with weighted material to prevent displacement in the event

of a collision. Ensure planters installed do not interfere with routine operations, visibility, or emergency response access.

- **Traffic Regulatory Signage**

Post regulatory traffic signage in and around the parking lot to remind drivers of traffic flow and vehicle speed regulations. Ensure crosswalks, waiting areas, and high-risk areas are appropriately marked to inform passing motorists.

- **Bollard Installation**

Install bollards along vulnerable areas in the parking lot. Bollard size and depth are determined by the vehicular threat level and should typically not exceed 30 inches in height. Bollard spacing should be between 36 to 48 inches (0.9 and 1.2 meters), comply with ADA regulations, and facilitate emergency response access.

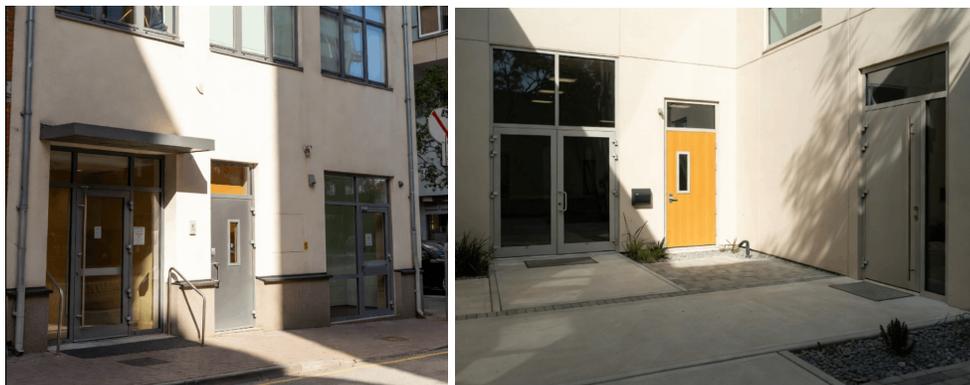
#### **Vulnerability: Excessive Access Points**

There are multiple access points along the building frontage providing access to the facility. An excess number of access points can make the facility more susceptible to unauthorized entry. Multiple access points are difficult to monitor and make proper access control challenging. Additionally, efforts to secure the facility in a lockdown may be delayed.

- **Access Point Minimization**

Depending on security resources available, access using entry points along the building frontage should be limited to one single entry point, where visitors can be screened appropriately before entering the facility. Alternate access points may serve as exits or entryways for credentialed staff and authorized personnel. Preferably, alternative entrance points should be equipped with remote monitoring, intrusion detection, and designed to prevent entry of unauthorized personnel.

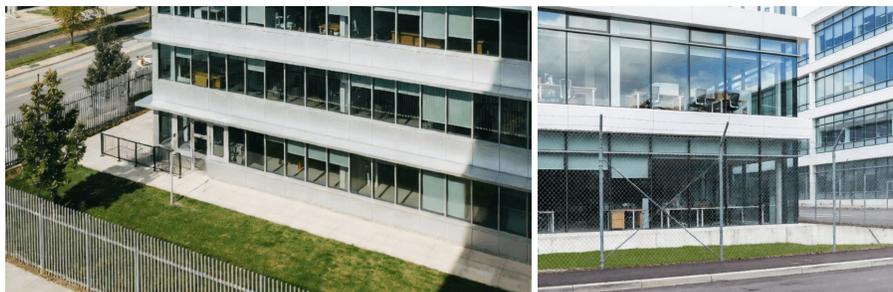
- **Vulnerability: Structural Weakness/Unprotected Glass**

The material or design of the building frontage is not resilient and may be vulnerable to damage or intrusion. Materials such as unprotected glass and hollow wood increase the risk of potential intrusion, damage to the facility, or injury to personnel. In an explosion, lite materials such as glass and wood may be projected into the facility at high speed, resulting in injury or damage.

- **Glass Protection Film**

Treat the unprotected glass along the building frontage with shatter resistant, fragment retention, tinted and anchored protective security film. While the security film may limit glass fragmentation and delay an intrusion, the tinting will provide additional privacy screening so an aggressor cannot easily see inside the building.

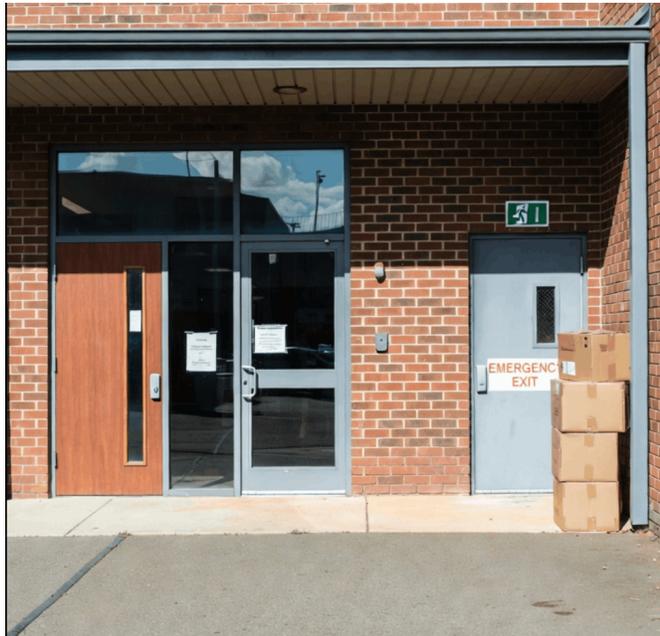
### **Vulnerability: Rapid Egress Denial- Fire Hazard**

The emergency exit door/gate may violate fire code, potentially restricting or delaying emergency egress of facility occupants. A malfunctioning lock, improperly installed locking device or blocked route may result in delayed and disorderly evacuation in case of an emergency.

- **Egress Pathway Clearance**

Ensure the area leading to and around the emergency exit is clear of debris and clutter to facilitate quick evacuation in case of an emergency.

- **Crash Bar Installation**

Install a crash bar on the emergency exit's interior, which quickly unlocks when pressure is applied in the direction of egress. Ensure a door spring is installed to prevent the door from remaining open after use.

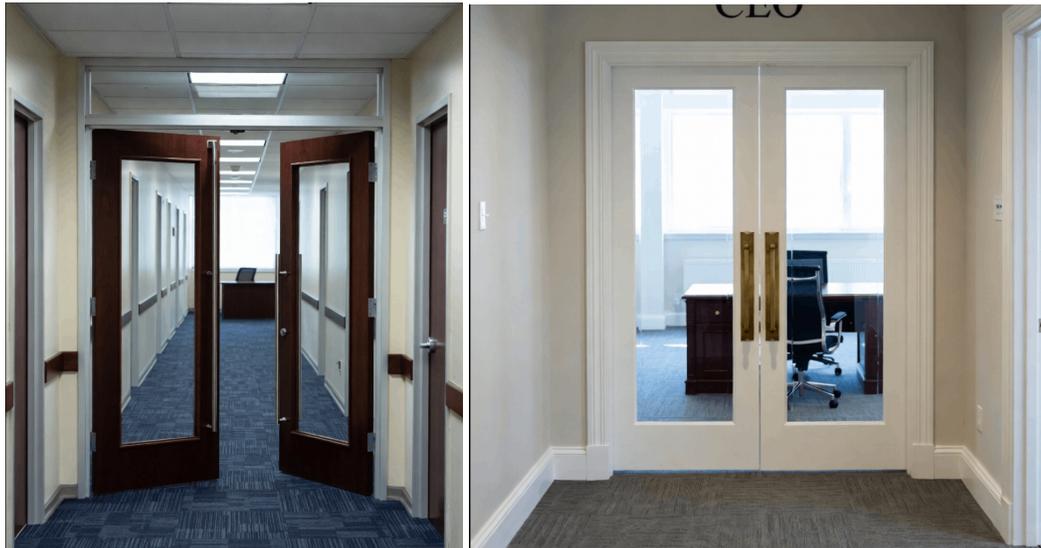
### **Vulnerability: Insufficient Access Control**

Access to the main office is not adequately controlled through one or more of its entrances. Facility equipment, property or personnel may be at risk. In the case of an incident, the ability to conduct a proper post-incident investigation is limited.

- **Locking Device Installation**

Ensure access to the main office is adequately controlled using a conventional lock, electronic or mechanical key code, RFID card reader/Fob or facial/biometric system to verify the authenticity of persons entering the area. For an office requiring elevated security measures, two-factor authentication access control may be considered. Distribute keys and/or RFID cards to authorized personnel, implementing proper documentation and tracking procedures. Avoid providing keys to vendors and ensure keys cannot be easily duplicated.

- **Vendor Escort Procedure**

Ensure vendors and maintenance personnel seeking access to the main office are accompanied and observed by authorized facility personnel throughout the duration of their required stay.

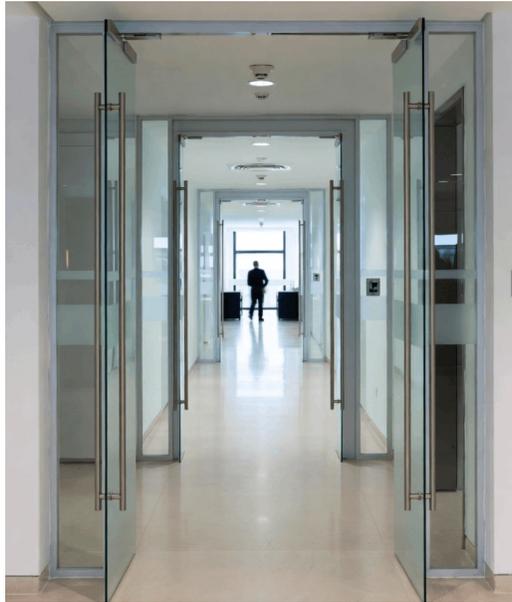
MC L **Vulnerability: Unprotected Glass**

The main office design incorporates unprotected glass which may increase the risk of intrusion and limit the ability to thoroughly lockdown the room. In the case of an explosion, extreme weather, or seismic event, glass fragments may cause injury to personnel.

- **Glass Protection Film**

Treat unprotected glass in the main office with shatter resistant, fragment retention, anchored protective security film. Window tinting may be considered for added privacy.

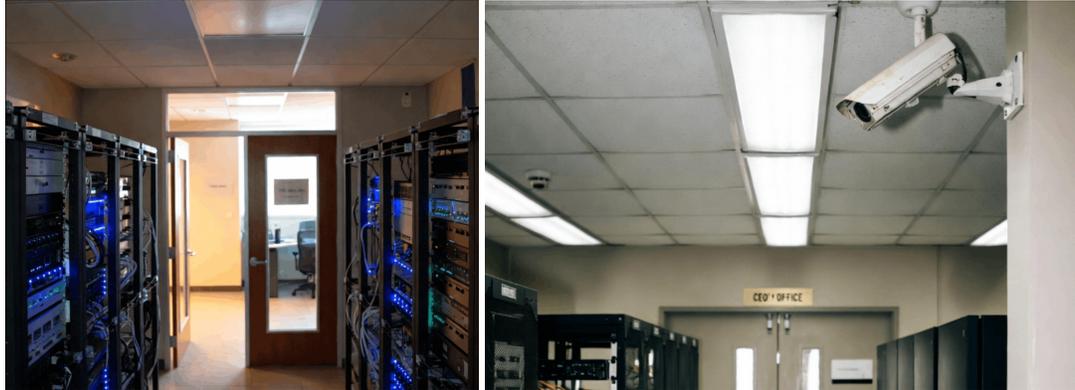
MA H **Vulnerability: Insufficient Security Camera Coverage**

Activity in the IT/server room is not sufficiently monitored and/or documented by a security camera system. The ability to identify and track individuals accessing the room or respond to unlawful activity is limited and may be delayed, potentially exposing property and personnel to associated risks. Limited security cameras may encourage unlawful or unauthorized activity in unsupervised areas and hinder the ability to conduct a thorough post-incident investigation.

- **Security Camera Replacement**

Install security camera/s to monitor activity within the IT/server room. Adequate security camera coverage may substitute the need for frequent patrols to the area. Ensure camera placement facilitates the identification of all individuals entering or exiting the room. The camera type/model installed should function in all lighting conditions providing coverage of the entire room. For increased deterrence, install cameras in overt locations, strategically placed to avoid vandalism or sabotage. Motion sensors may also be used to detect movement in vulnerable areas and prioritize monitoring.

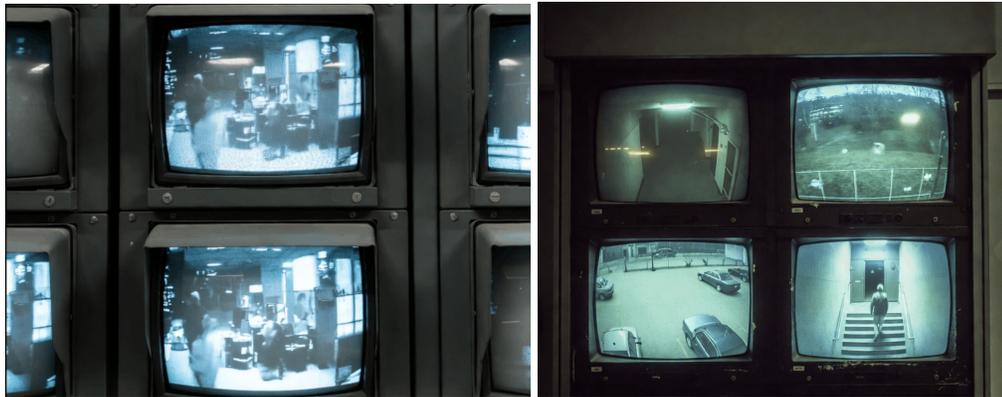
**Vulnerability: Outdated Security Camera System**

The existing video assessment and surveillance system is outdated. The cameras render poor image quality, may not be IP accessible and have limited sensory and analysis capability. Although functional, the current system does not meet modern technological standards and offers limited surveillance capability. The use of outdated equipment provides a false sense of security and may require additional resources to ensure minimum security standards are met.

- **Security Camera System Upgrade**

Upgrade the facility's existing video surveillance system. Install surveillance cameras along the facility's perimeter, around access points, intakes and in areas where vehicles or pedestrians may approach the facility undetected. Ensure cameras are also installed to monitor activity indoors and in common areas. For maximum effectiveness, cameras should be monitored continuously and in real-time. Install most cameras in overt areas to maximize deterrence. Place cameras in locations with a sufficient view of the desired area where they are not vulnerable to vandalism, sabotage, or environmental damage. Ensure the new system is IP or network accessible. The installation of IP-based electronic security systems can be installed independently of major facility renovations.
