Security Assessment Report
School Security
Assessment

School Administration
4885 Park Ridge Blvd
Boynton Beach, FL, 33426

Assessment Date: January 21, 2026

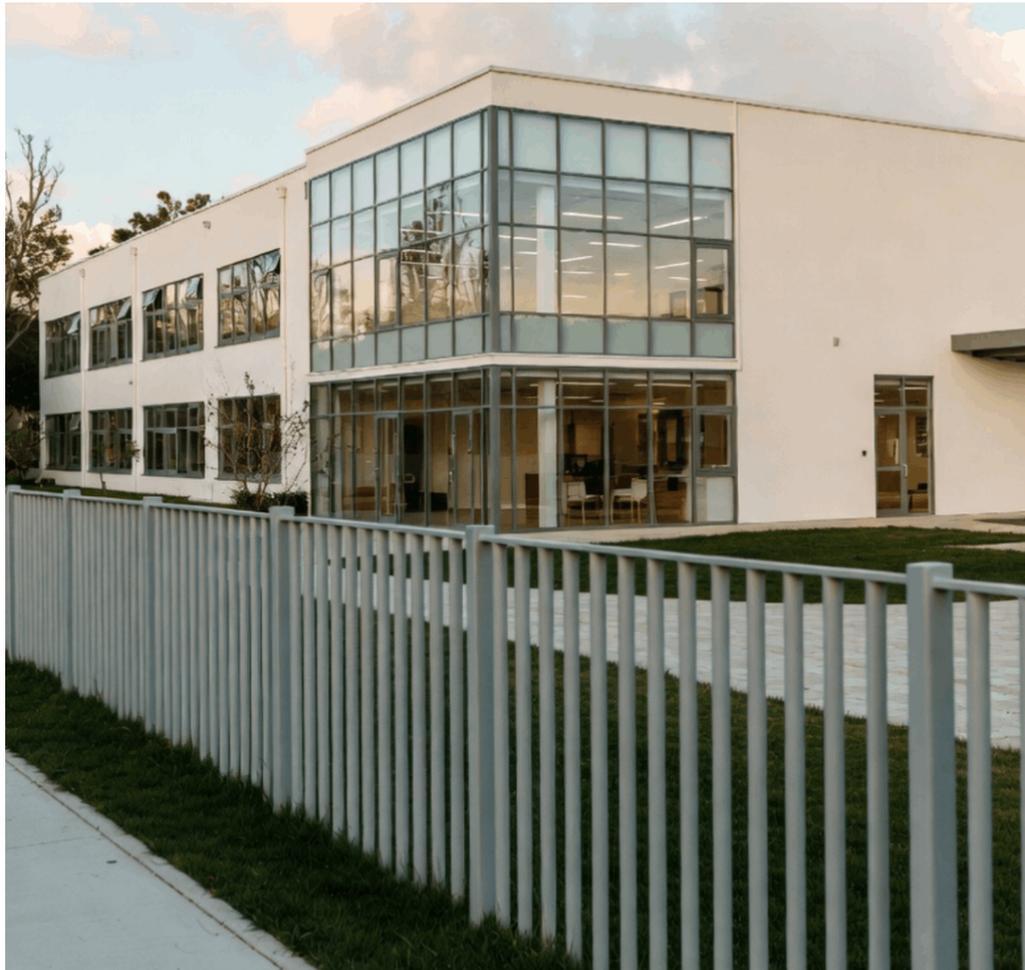
Vulnerability: Deficient Perimeter Fence/Wall

The facility is not enclosed within a perimeter boundary such as a fence or wall. The existing perimeter is insufficient and will not prevent an intruder from accessing exclusive areas.

- **Anti-Climb Fencing**

Install an anti-climb fence or wall. Different styles of anti-climb fencing are available, most consisting of vertical bars with horizontal supports designed to

make scaling difficult. Additional measures may include appropriate lighting, security cameras, alarm devices, and signage to augment the perimeter boundary.

- **Fencing/Wall Enclosure**

Install a perimeter fence or wall enclosing the facility within a physical boundary. Fencing types include but are not limited to chain-link, aluminum, anti-climb (CPTED), barbed wire, concertina, triple-stranded concertina, welded mesh, buried fencing, wrought iron, and wire, all of which are designed to deter and delay intrusion. Additional measures may include appropriate lighting, security cameras, alarm devices, and signage to augment the perimeter boundary.

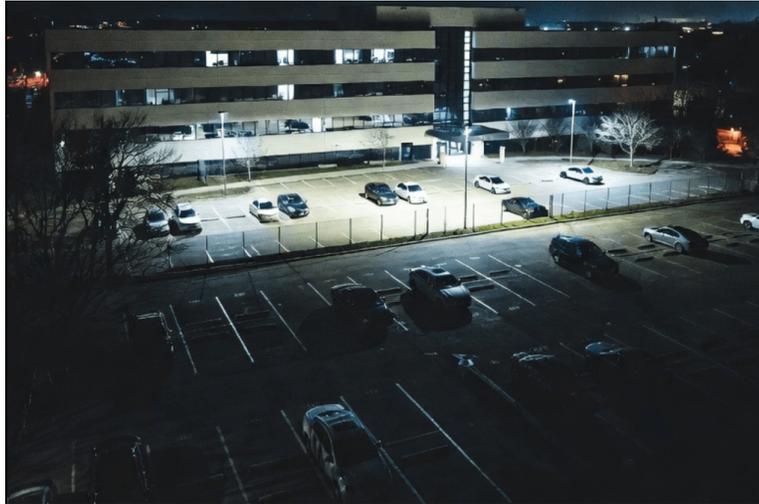
Vulnerability: Insufficient Lighting

There is insufficient lighting in the parking lot. Inadequate lighting creates general safety hazards and may promote unlawful activity in the area. Additionally, limited lighting may render existing surveillance equipment ineffective.

- **Illumination Quality Upgrade**

Upgrade the current parking lot light bulbs and/or luminaires for better illumination capabilities. Different light sources have different abilities and limitations. When choosing the optimum light source, various factors should be considered, such as the threat level, cost of change and usage, life usage expectancy (in hours), accessibility, maintenance, environment, and design

- **Standby Lighting**

Where continuous lighting is not required, install standby lighting within the parking lot. Standby lighting activates when motion is detected by the sensor.

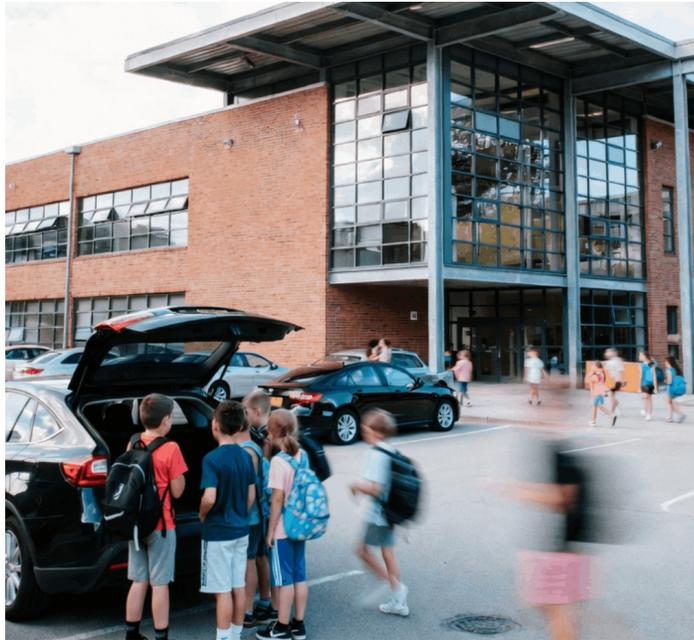
Vulnerability: Vehicular Impact

Both the facility's exterior and pedestrians in the parking lot are vulnerable to vehicular impact. Injuries and/or structural damage may occur due to an accidental or intentional vehicular incident.

- **Planter Placement**

Place planters in strategic locations in and around the parking lot. Planters should be anchored and filled with weighted material to prevent displacement in the event of a collision. Ensure planters installed do not interfere with routine operations, visibility, or emergency response access.

- **Bollard Installation**

Install bollards along vulnerable areas in the parking lot. Bollard size and depth are determined by the vehicular threat level and should typically not exceed 30 inches in height. Bollard spacing should be between 36 to 48 inches (0.9 and 1.2 meters), comply with ADA regulations, and facilitate emergency response access.

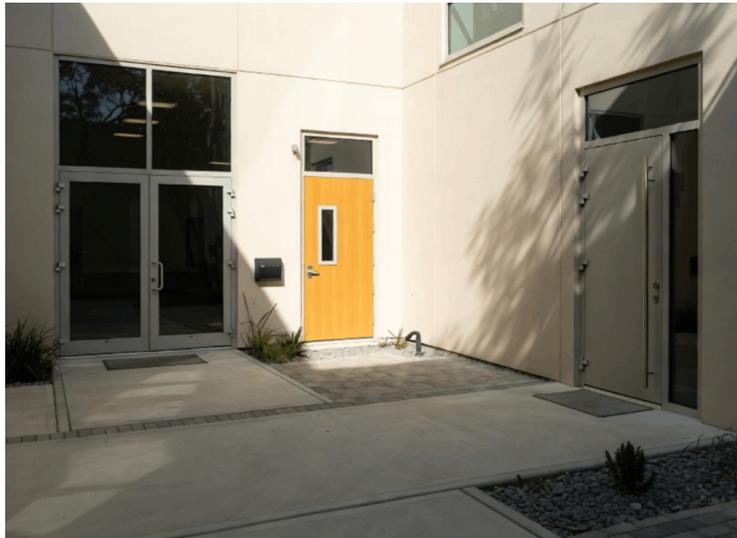
Vulnerability: Excessive Access Points

There are multiple access points along the building frontage providing access to the facility. An excess number of access points can make the facility more susceptible to unauthorized entry. Multiple access points are difficult to monitor and make proper access control challenging. Additionally, efforts to secure the facility in a lockdown may be delayed.

- **Access Point Minimization**

Depending on security resources available, access using entry points along the building frontage should be limited to one single entry point, where visitors can be screened appropriately before entering the facility. Alternate access points may serve as exits or entryways for credentialed staff and authorized personnel. Preferably, alternative entrance points should be equipped with remote monitoring, intrusion detection, and designed to prevent entry of unauthorized personnel.

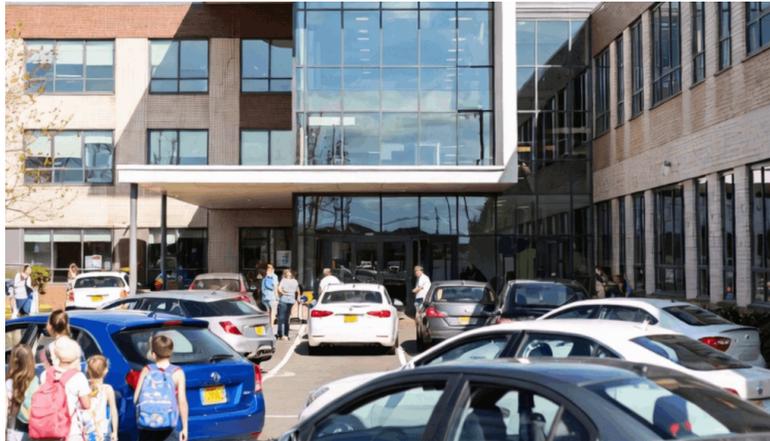
Vulnerability: Structural Weakness/Unprotected Glass

The material or design of the building frontage is not resilient and may be vulnerable to damage or intrusion. Materials such as unprotected glass and hollow wood increase the risk of potential intrusion, damage to the facility, or injury to personnel. In an explosion, lite materials such as glass and wood may be projected into the facility at high speed, resulting in injury or damage.

- **Glass Protection Film**

Treat the unprotected glass along the building frontage with shatter resistant, fragment retention, tinted and anchored protective security film. While the security film may limit glass fragmentation and delay an intrusion, the tinting will provide additional privacy screening so an aggressor cannot easily see inside the building.

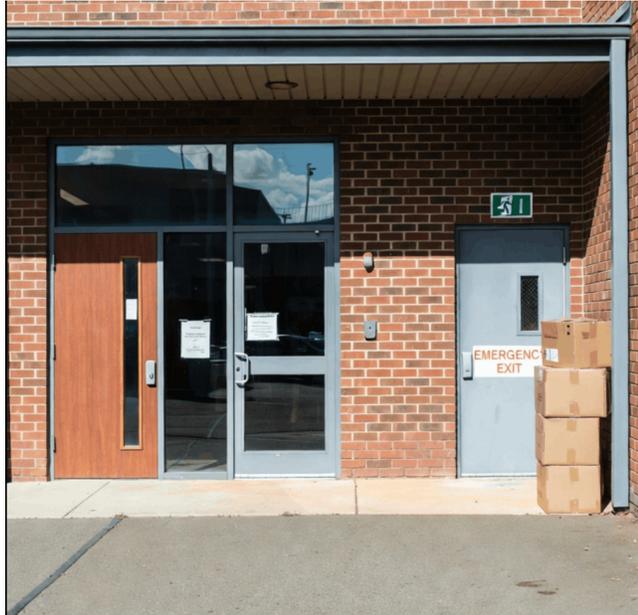
Vulnerability: Rapid Egress Denial- Fire Hazard

The emergency exit door/gate may violate fire code, potentially restricting or delaying emergency egress of facility occupants. A malfunctioning lock, improperly installed locking device or blocked route may result in delayed and disorderly evacuation in case of an emergency.

- **Egress Pathway Clearance**

Ensure the area leading to and around the emergency exit is clear of debris and clutter to facilitate quick evacuation in case of an emergency.

- **Crash Bar Installation**

Install a crash bar on the emergency exit's interior, which quickly unlocks when pressure is applied in the direction of egress. Ensure a door spring is installed to prevent the door from remaining open after use.

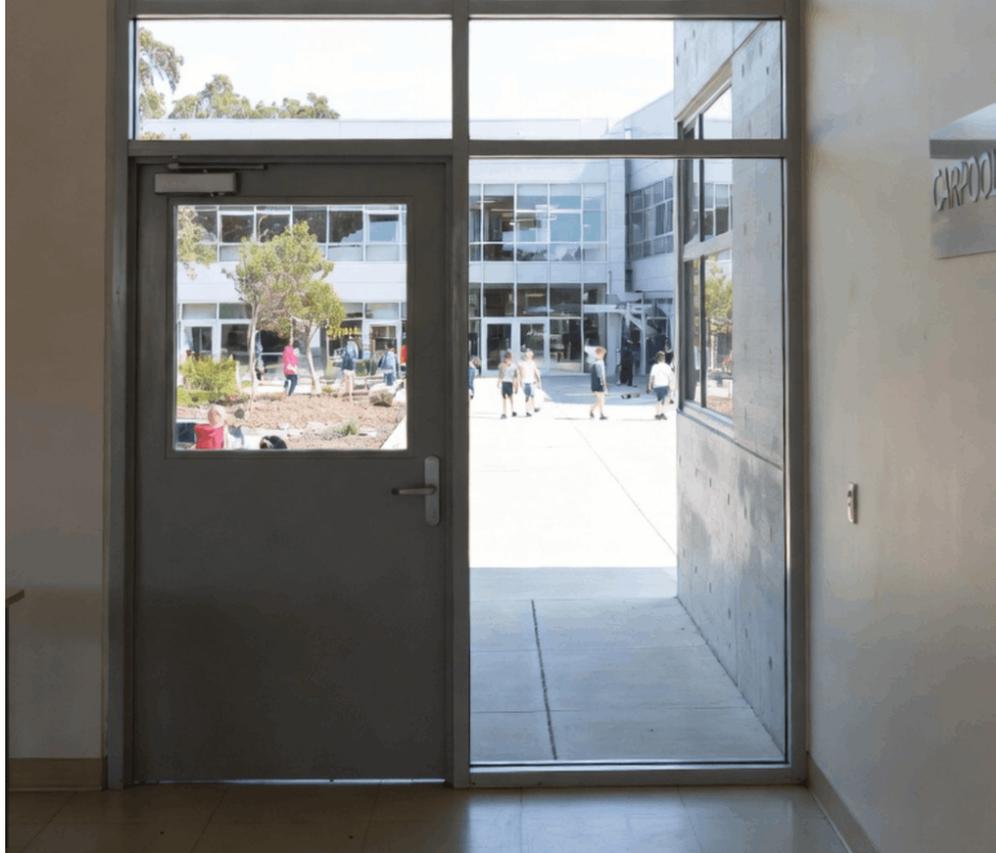
Vulnerability: Enables Interior Surveillance

The arrangement and design of the classroom enables outside observation into the room. Although the configuration may facilitate a positive study environment, observation allows an aggressor to collect valuable information on occupants and

security measures. Additionally, the design limits the number of locations affording sufficient concealment for staff and students.

- **Tinted Glass Film**

Install sufficient window tinting or frosting film on the classroom windows to restrict outside observation into the room. Window tinting is particularly effective when interior lighting is turned off.

- **Curtains/Shades Installation**

Furnish pertinent windows with curtains or shades in the classroom to ensure interior activity cannot be viewed from outside the room in an emergency.

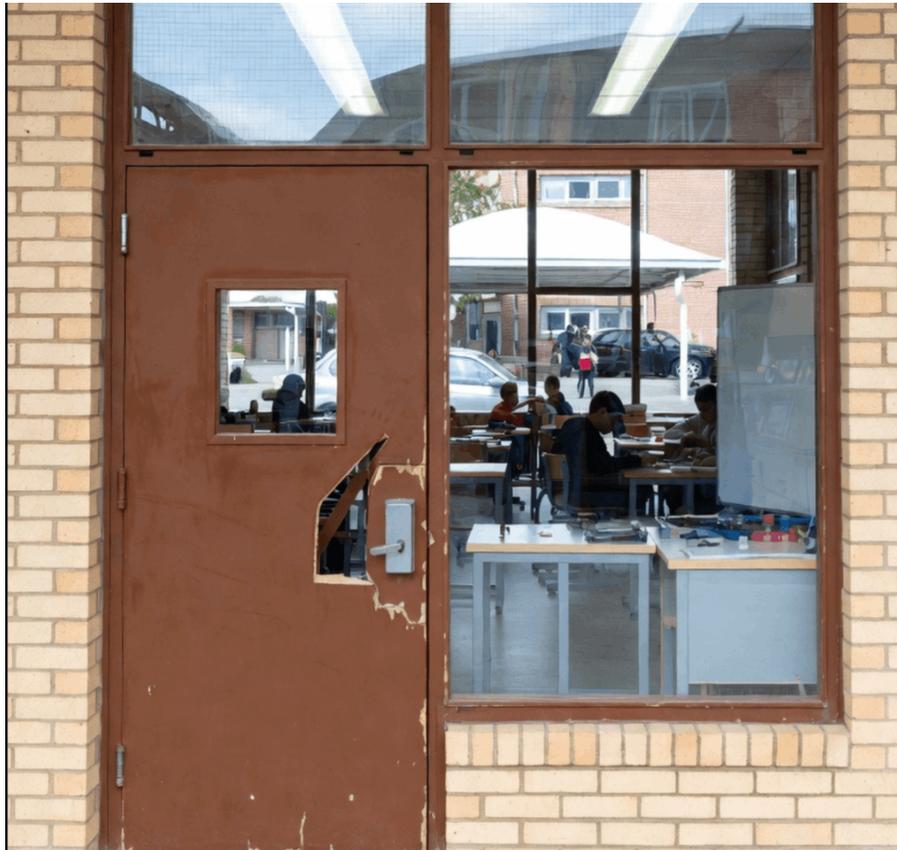
Vulnerability: Insufficient Access Control

Access to the classroom is not adequately controlled through one or more of its entrances. School equipment, sensitive information, property or personnel may be at risk. In the case of an incident, the ability to conduct a proper post-incident investigation is limited.

- **Entrance Door Repair/Replacement**

Repair/replace the classroom entrance door, ensuring it properly seats when closed and locks securely in place.

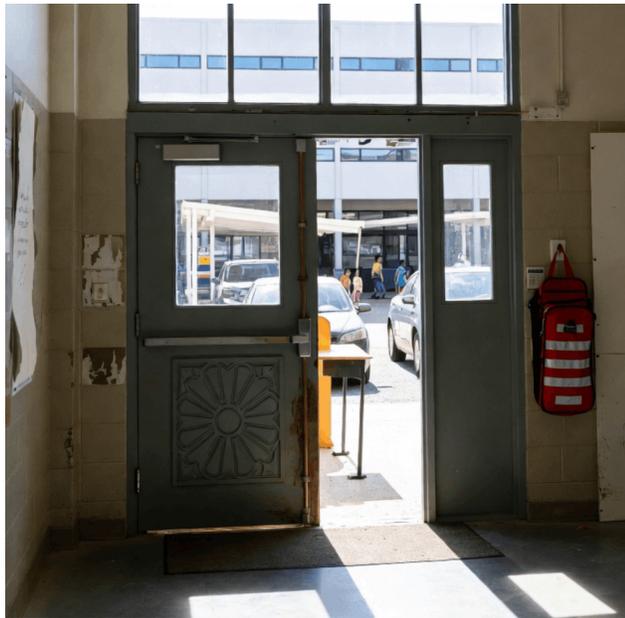
MA **H** **Vulnerability: Deficient Emergency Equipment**

The classroom emergency "Go" bags are missing key items. Occupants will not have access to critical supplies in case of an emergency evacuation.

- **Periodic Inventory Inspection**

Periodically inspect and inventory emergency bags to ensure readiness and compliance. Inventory checks should be documented and expired medical supplies should be removed and replaced.
